Technical release

Mixing VAM copies with NEW VAM in one same string may lead to operational failures

Mixing VAM copies with NEW VAM in one same string

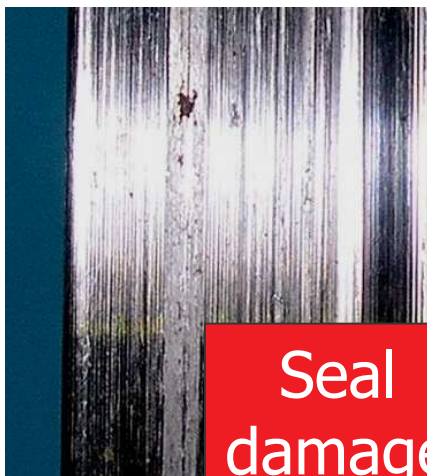
Seal damage

Testing procedures show 1 end over 4 out of tolerance

Physical tests results - Pin "VAM copy" / box NEW VAM			
	Make & Breaks	Internal pressure	Tension
7" 29 lb/ft VAM copy A	Seal damage	Leakage	Jump out
7" 26 lb/ft VAM copy B	OK	Leakage	OK

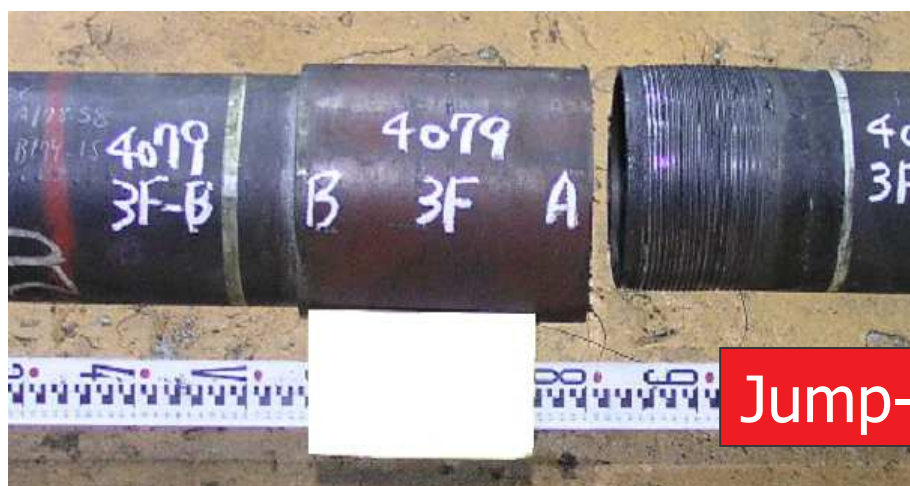
Jump-out
